CASE STUDY

CERALOOP FOR BRASS

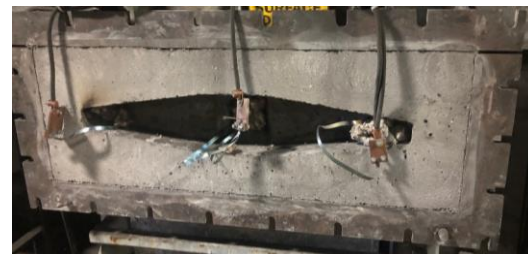
Traditional Cast Inductor

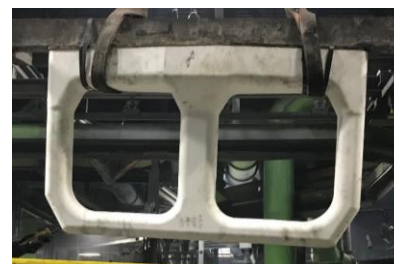
Profile of the twin bushing CeraLoop™

CeraLoop™ precast shape with DRI-VIBE® for the back-up lining

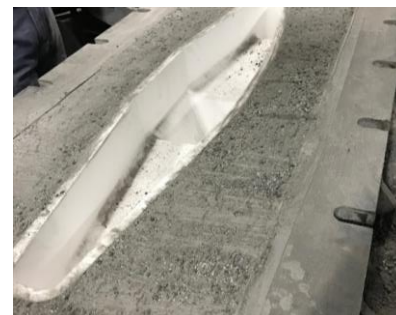
CeraLoop™ installed with DRI-VIBE® back-up

- The initial CeraLoop™ was installed in March 2019. The loop was installed utilizing a fused alumina-based DRI-VIBE backup. A standard start-up procedure was utilized, and the ceramic loop was operated until August 2019. Total lining campaign was approximately two times the total tonnage which was currently be experienced. The ceramic loop remained intact during inspection.
- The second ceramic loop was installed in October 2019 with a cast backup (the same material as is utilized in the uppercase). The loop remained in service for 300% of the campaign length. Additional loops have been manufactured to re-install in this inductor case and in other inductors in the foundry. The customer is pleased with the product durability, the increased performance, and the ease of installation.

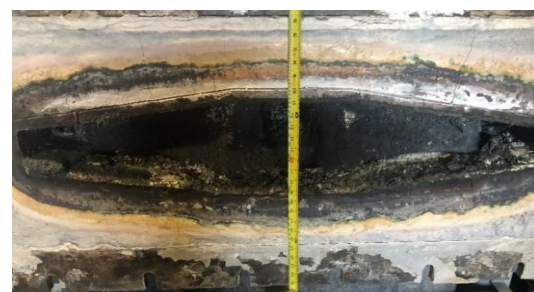
First CeraLoop™ after inductor removal, remained intact during productions
