# ARMORMAX 70 SR refractory perimeter Heat treating car bottom furnace deck

## Case study

- 25'L x 9'9"W #3 car bottom furnace deck

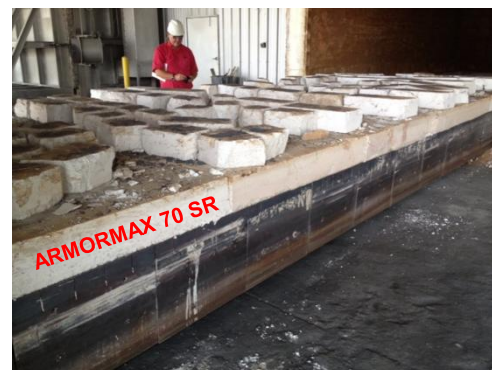
ARMORMAX 70 SR perimeter adjacent to competitive 70% alumina castable

- August 2013: The competitive 60% alumina castable perimeter cracked and spalled after 5 months in service.
- ARMORMAX 70 SR appearance is unchanged since the March 2013 installation
- Removed the sections of competitive castable in #3 furnace and replaced it with ARMORMAX 70 SR
- Perimeter of #4 furnace was also replaced due to ARMORMAX's resistance to cracking and spalling
- Customer ordered precast pier blocks made from ARMORMAX 70 SR due to the outstanding performance in the cast perimeter

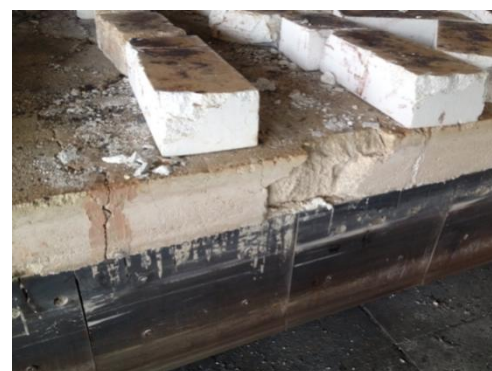
Closeup of competitive castable

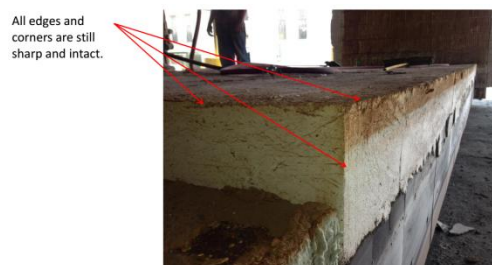
All edges and corners are still sharp and intact.

Closeups of ARMORMAX 70 SR

Notice that the Armormax 70 SR hasn't lost a top or corner edge after 5 months of service. The edges are as sharp as the day we cast them.
