## CASE STUDY:

### MATRIFLO 83ACX INSTALLATION IN A DIECASTING FURNACE

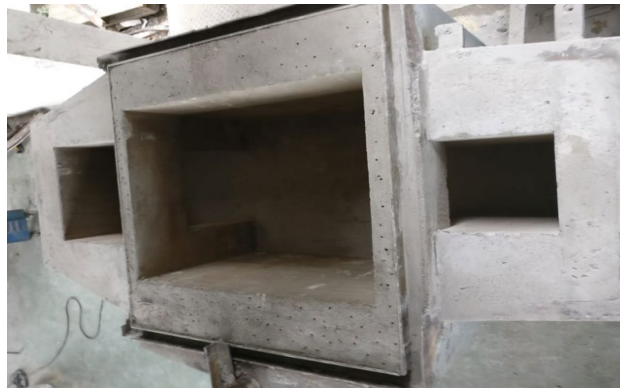
After 2 years in use, the furnace still looks new and is running well without any repairs needed. Additionally, we have lined five more holding furnaces.
